FIRE INVESTIGATION

Report One and Final

Insured: Nancy McNeil
Loss Location: Medford, Massachusetts
Date of Loss: October 11, 2001
Policy No.: HO12016316
Claim No.: Unknown
EFI File No.: 94507-17807

Report Date: November 8, 2001

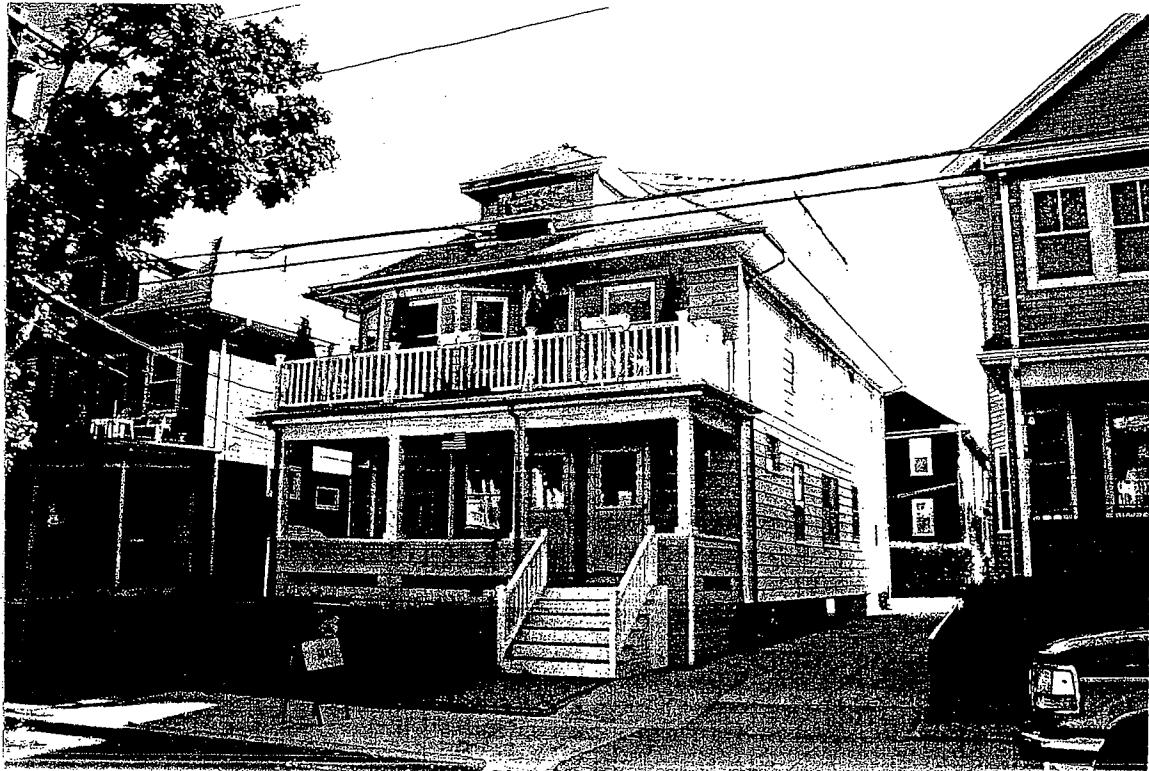
ENCLOSURE 3

Nancy McNeil, 48-50 Princeton Street, Medford, Massachusetts
